U. S. NAVAL PROVING GROUND
DAHLGREN, VIRGINIA

REPORT NO. 1095

RECOVERY FIRING OF 40MM PROJECTILE
COATED WITH MOLYBDENUM DISULFIDE

FINAL Report

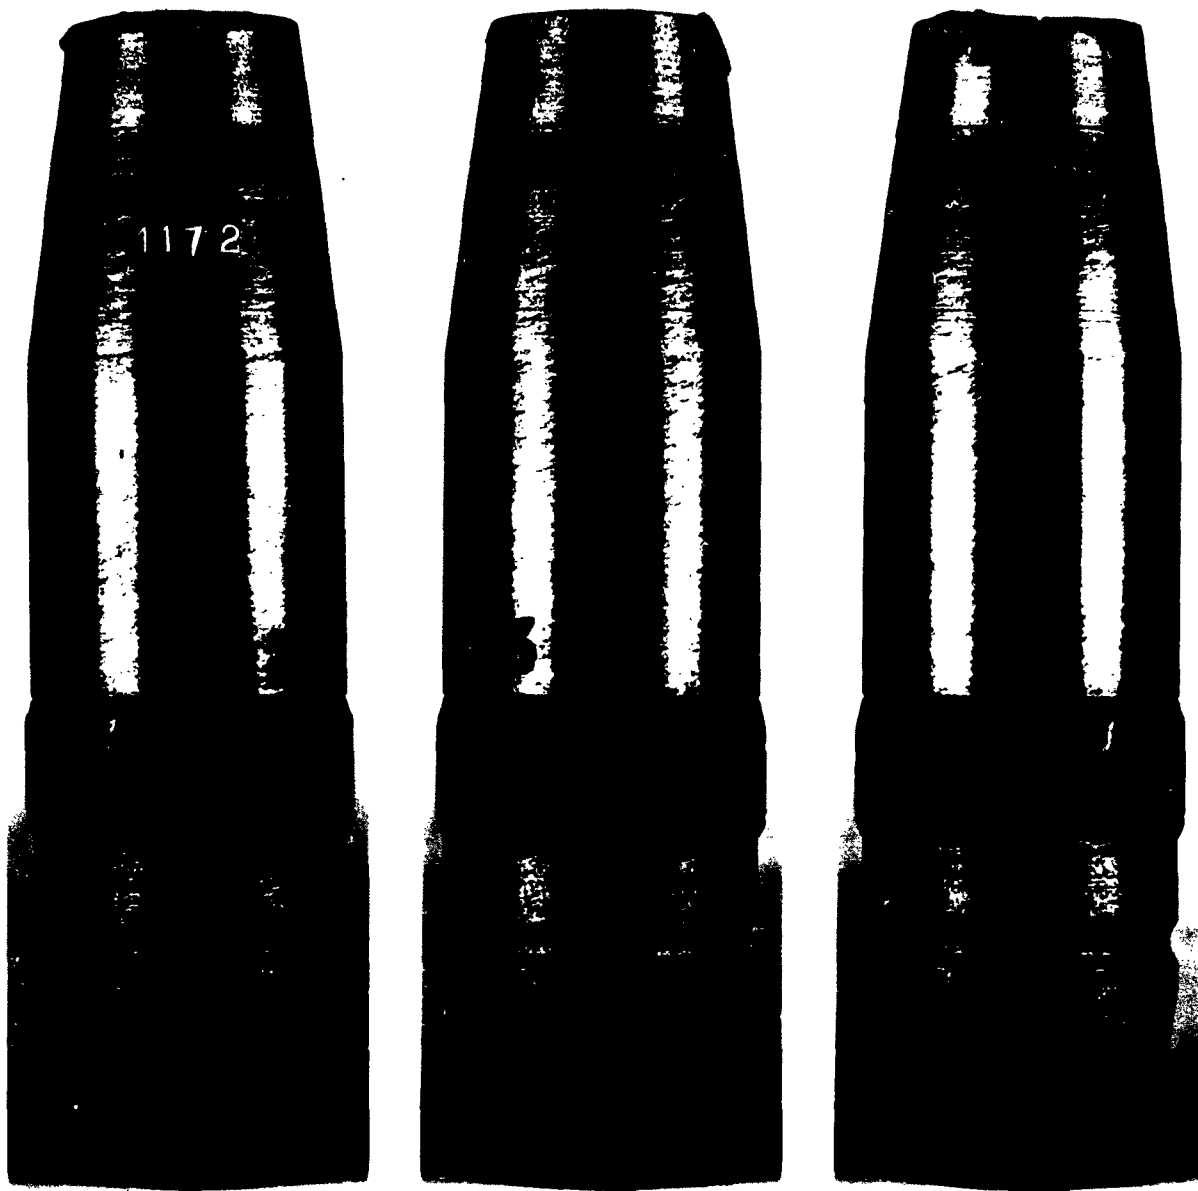
Figure 3

Three views (120° apart) of recovered 40mm T1E1 projectile (uncoated projectile and barrel). Projectile No. 1172.

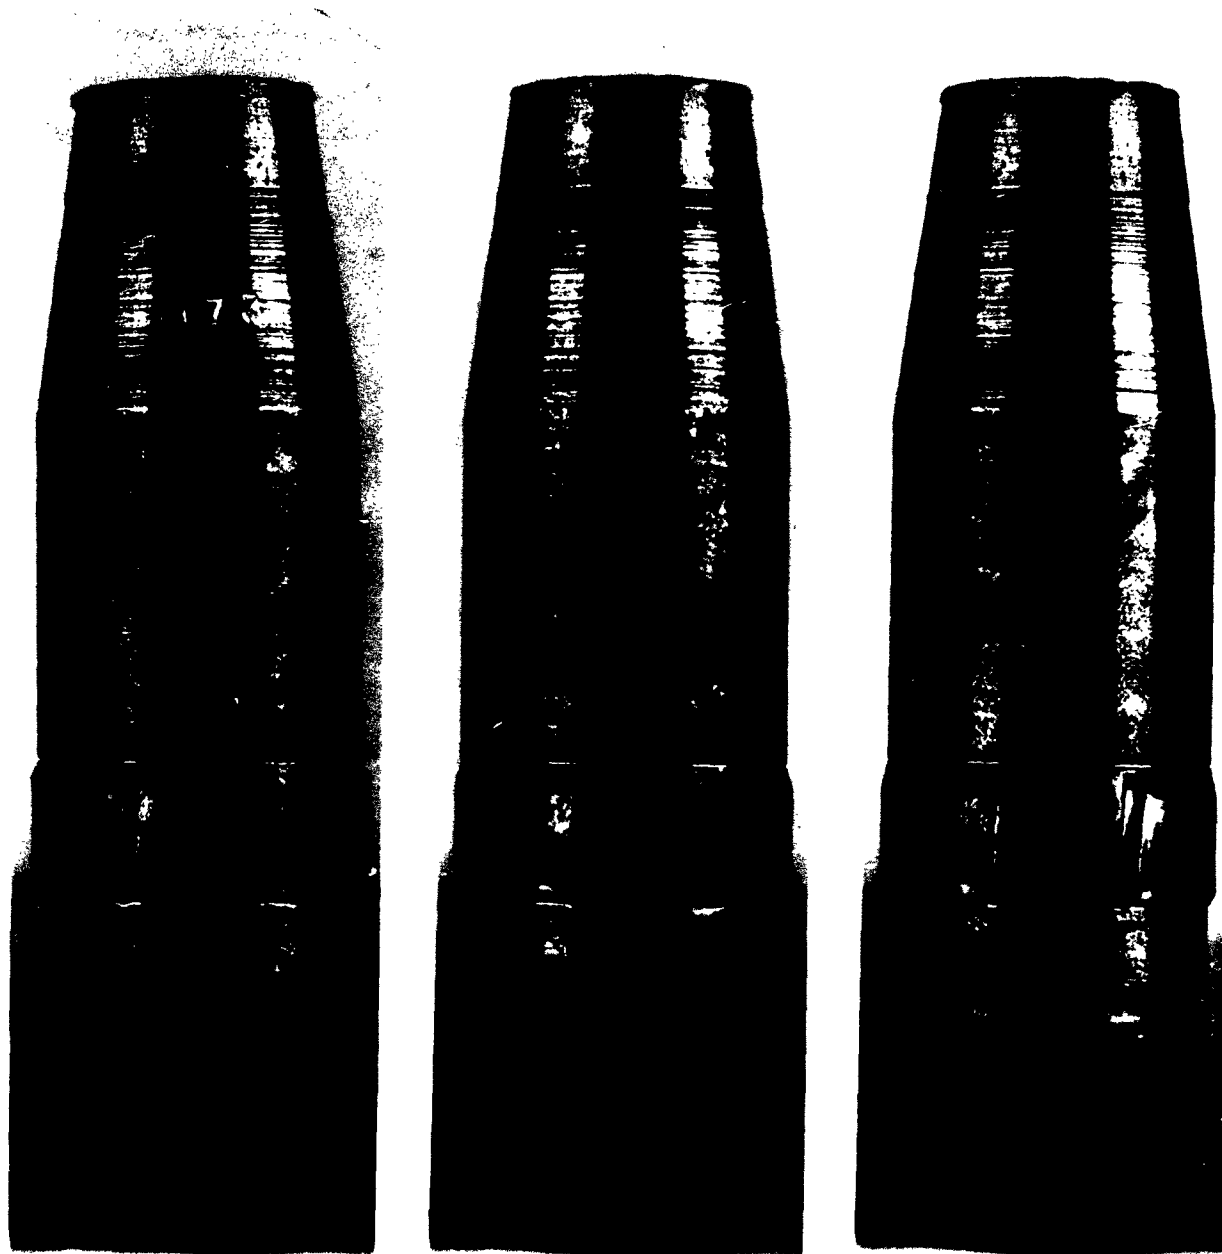
Figure 4

Three views (120° apart) of recovered 40mm T1E1 projectile (uncoated projectile and barrel). Projectile No. 1173.

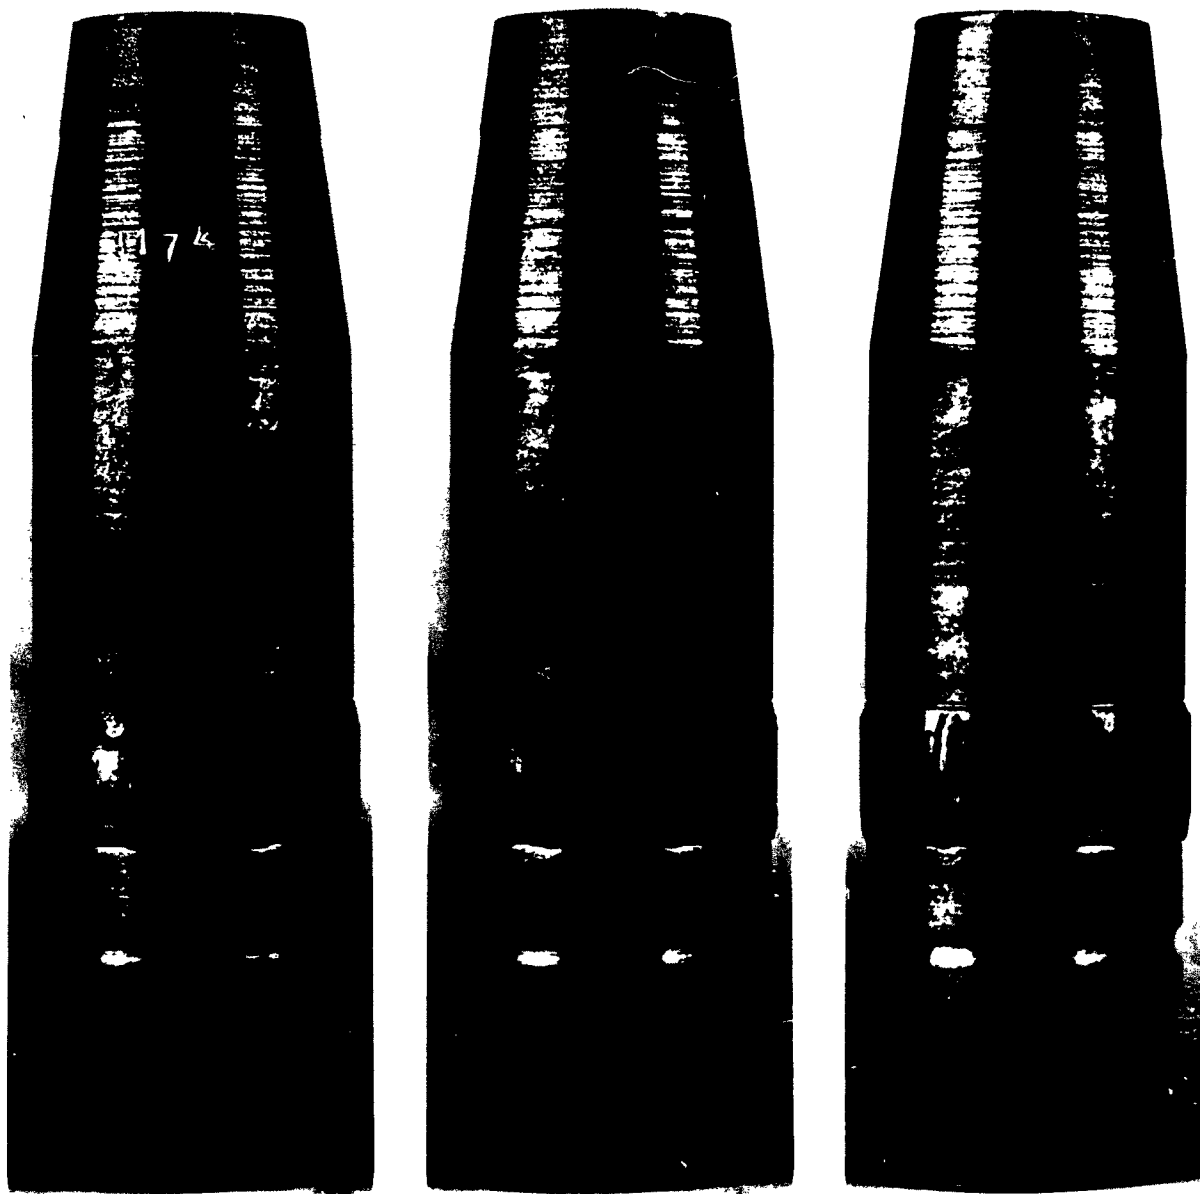
Figure 5

Three views (120° apart) of recovered 40mm T1E1 projectile
(band of projectile coated, uncoated barrel). Projectile
No. 1174.

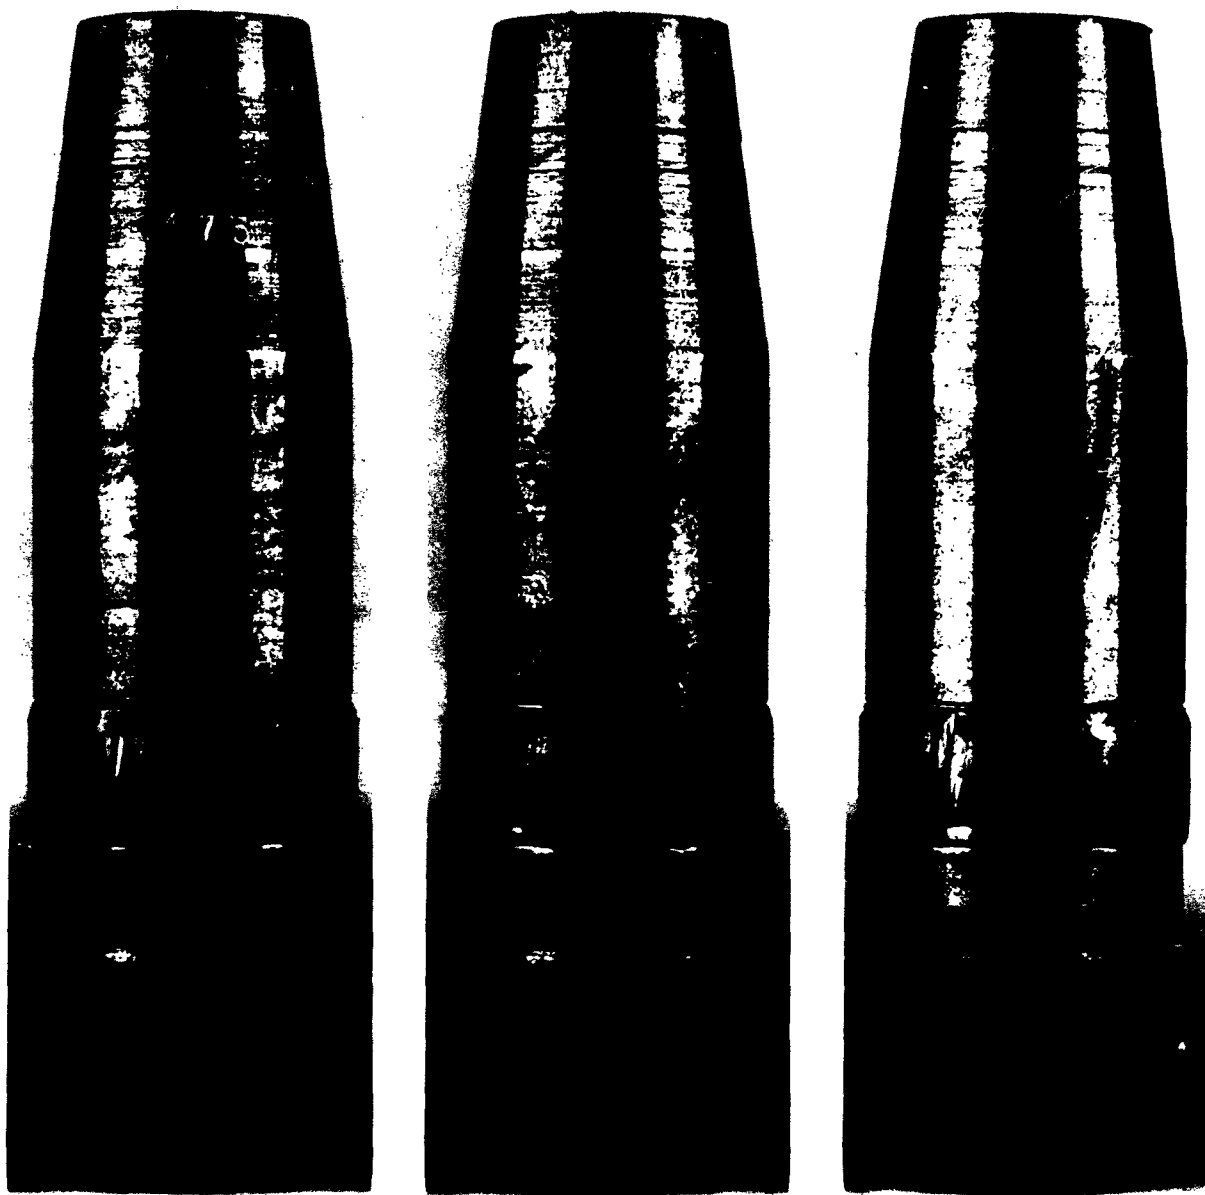
Figure 6

Three views (120° apart) of recovered 40mm T1E1 projectile
(band of projectile coated, uncoated barrel). Projectile
No. 1175.

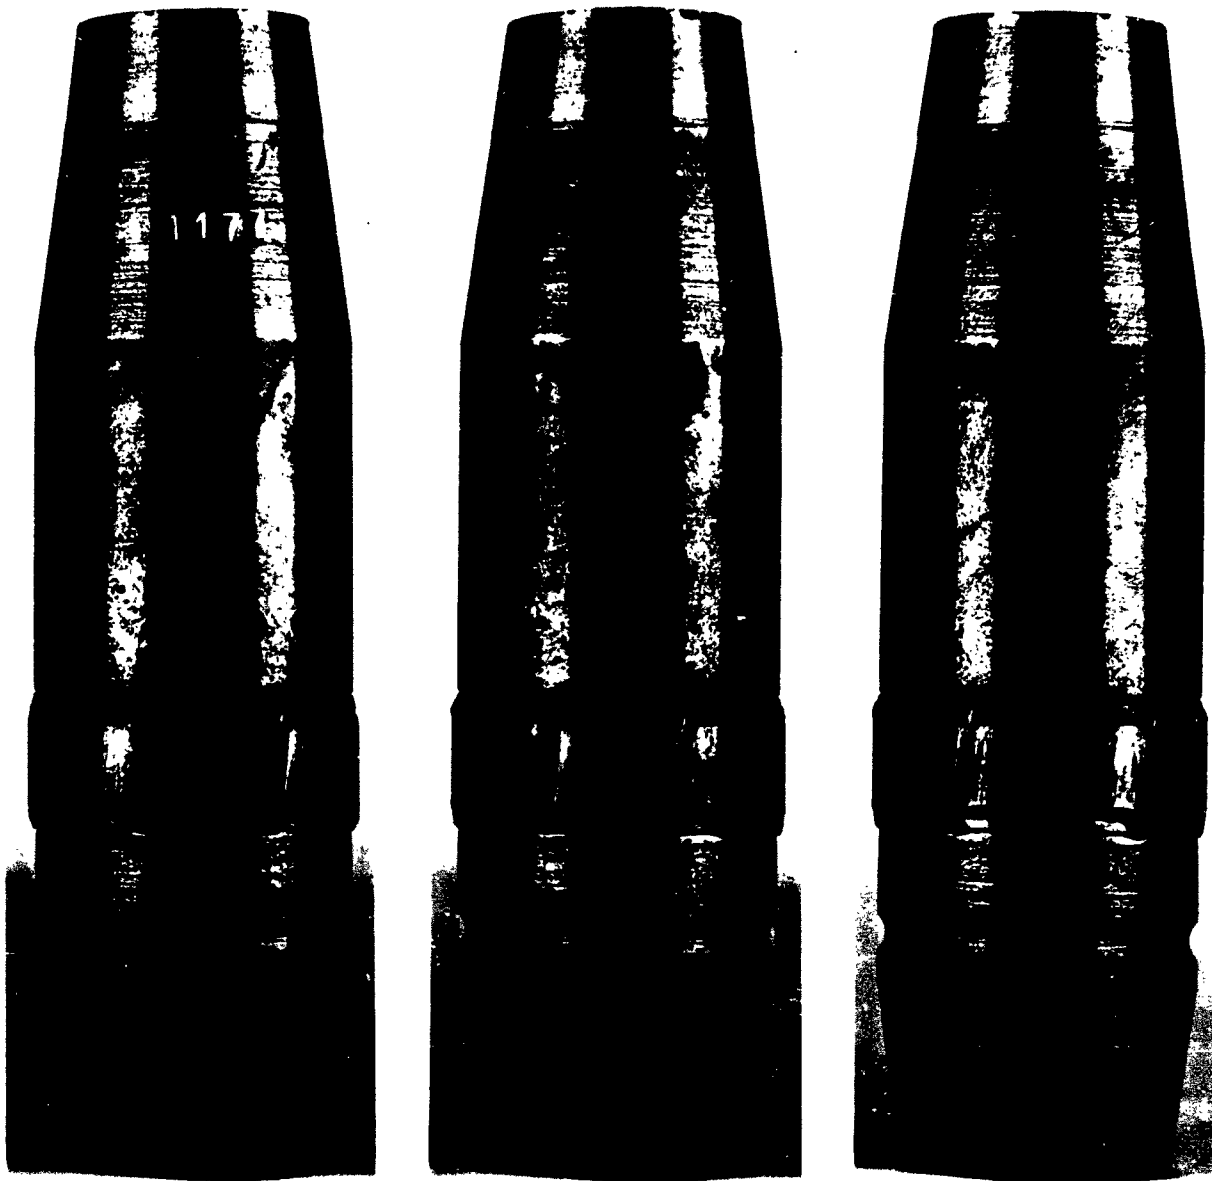
Figure 8

Three views (120° apart) of recovered 40mm T1E1 projectile (entire projectile coated, uncoated barrel). Projectile No. 1177.

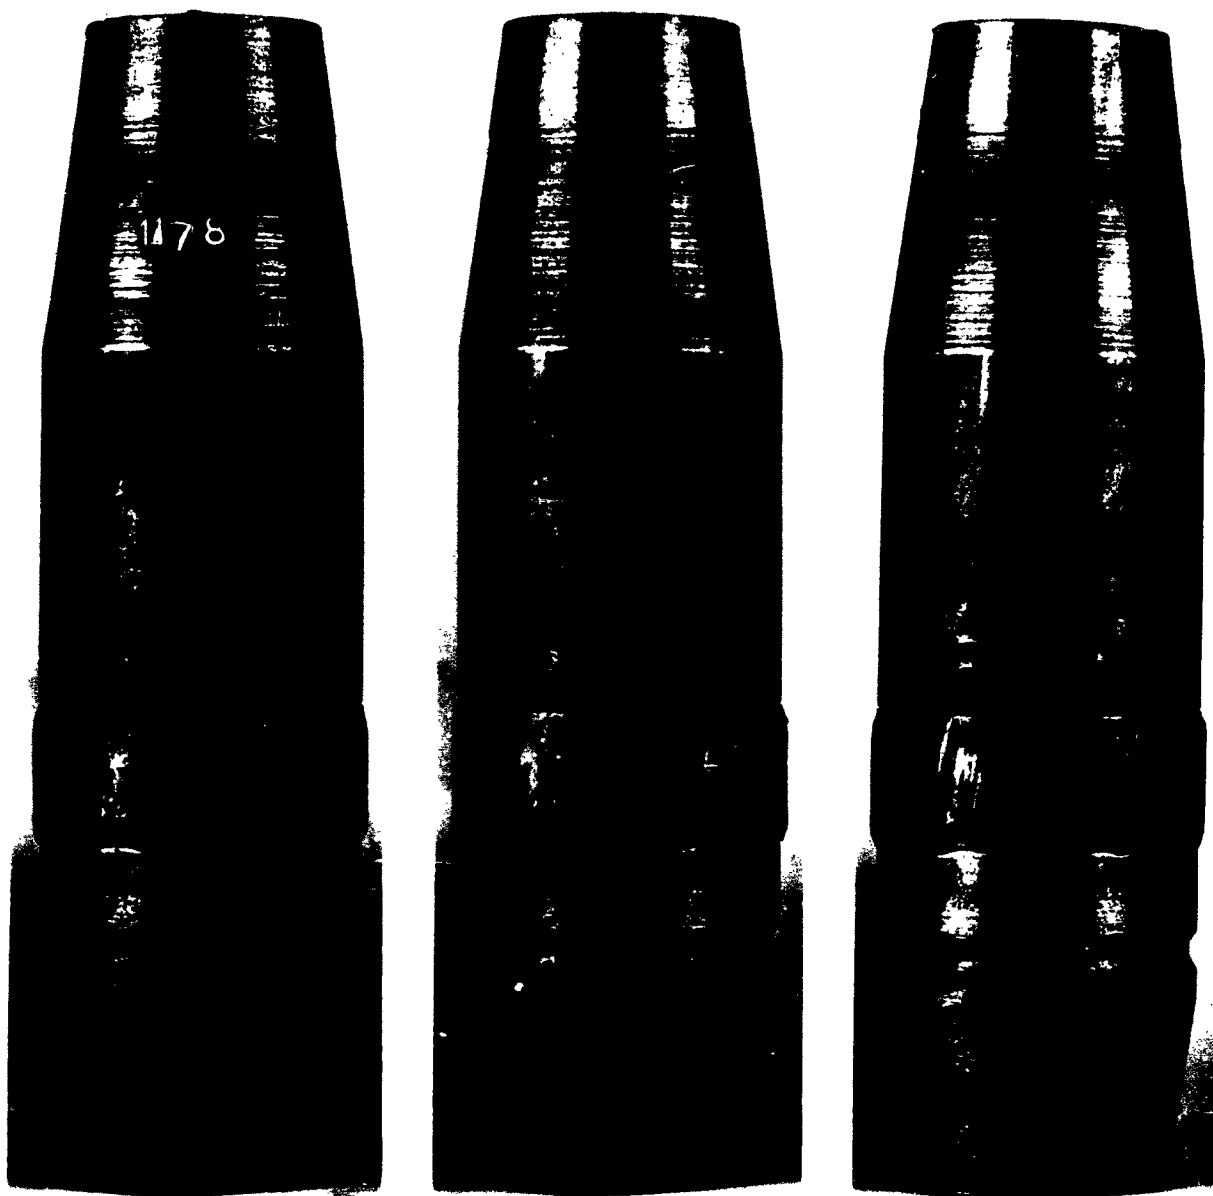
Figure 9

Three views (120° apart) of recovered 40mm T1E1 projectile (entire projectile coated, uncoated barrel). Projectile No. 1178.

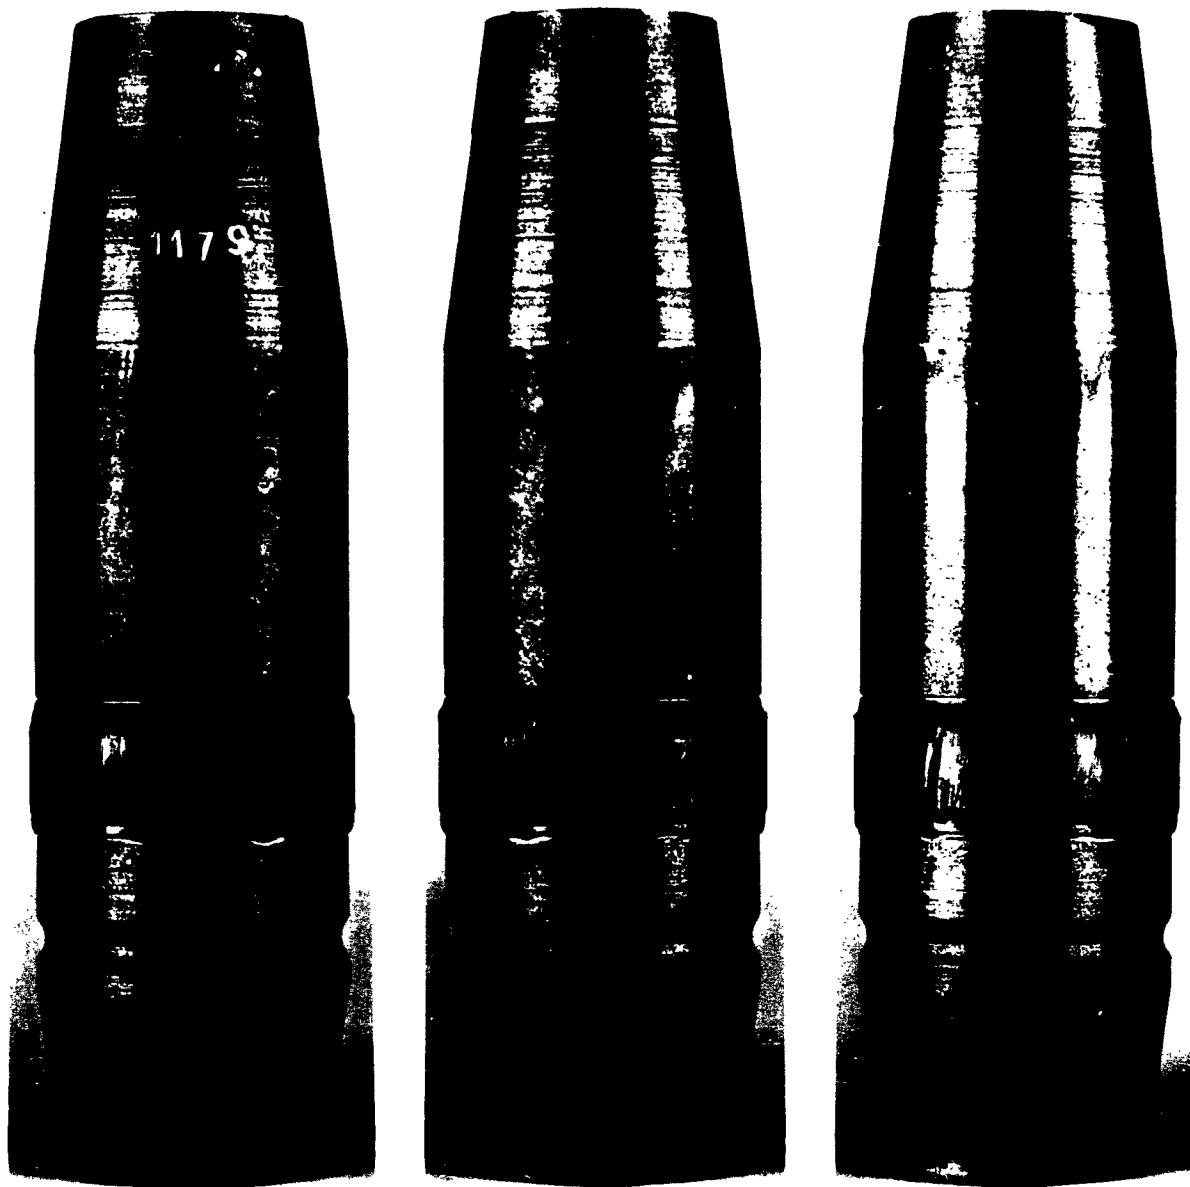
Figure 10

Three views (120° apart) of recovered 40mm T1E1 projectile (entire projectile coated, uncoated barrel). Projectile No. 1179.

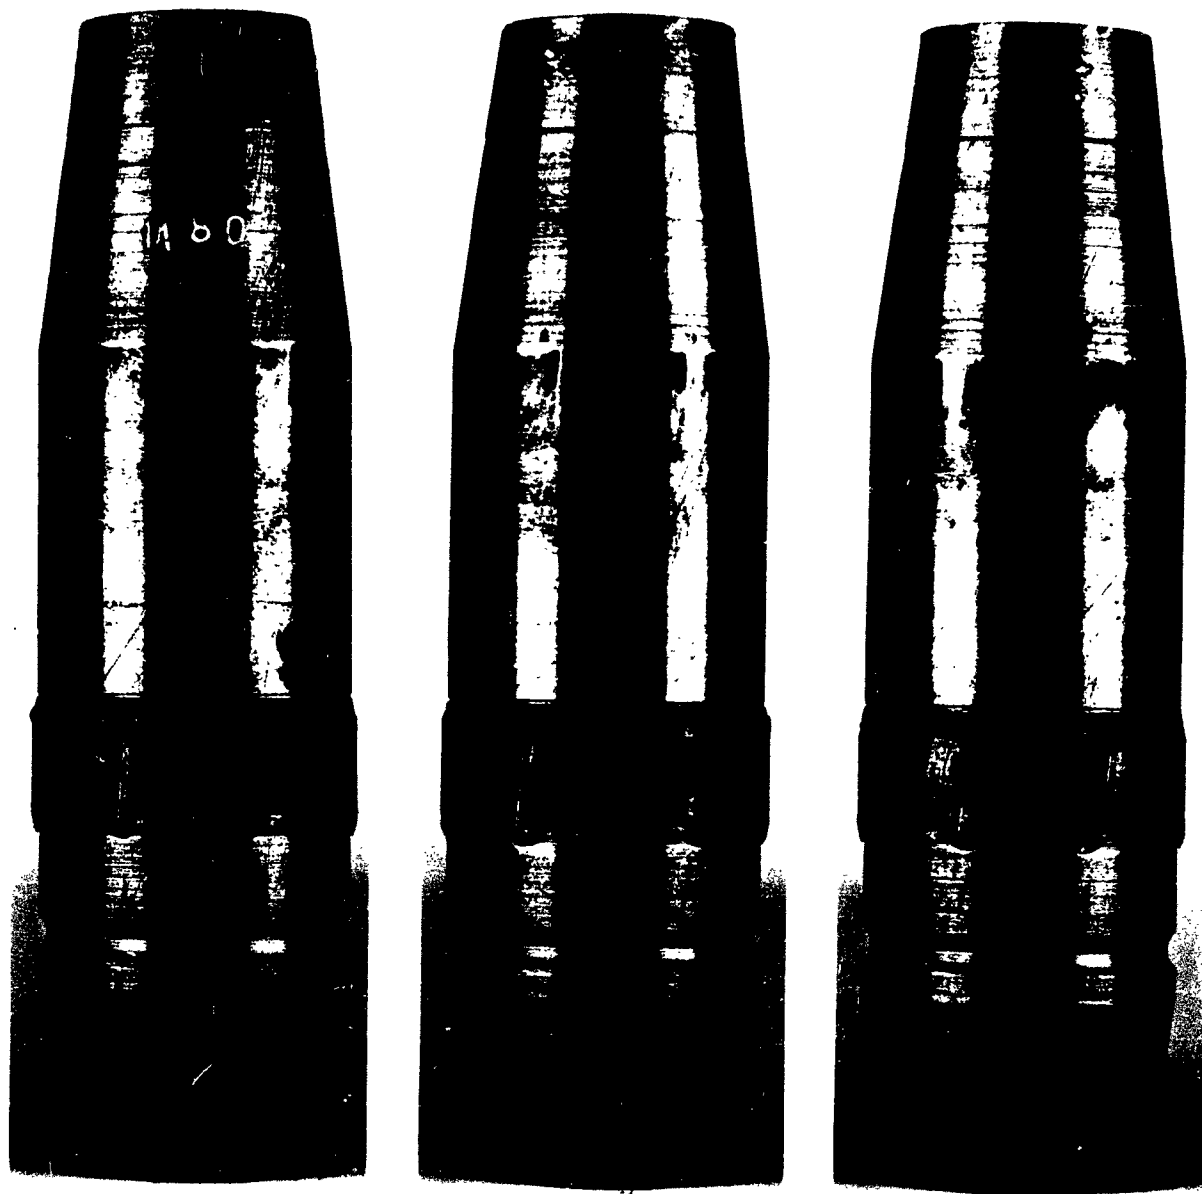
Figure 11

Three views (120° apart) of recovered
(warming round). Projectile No. 1180.

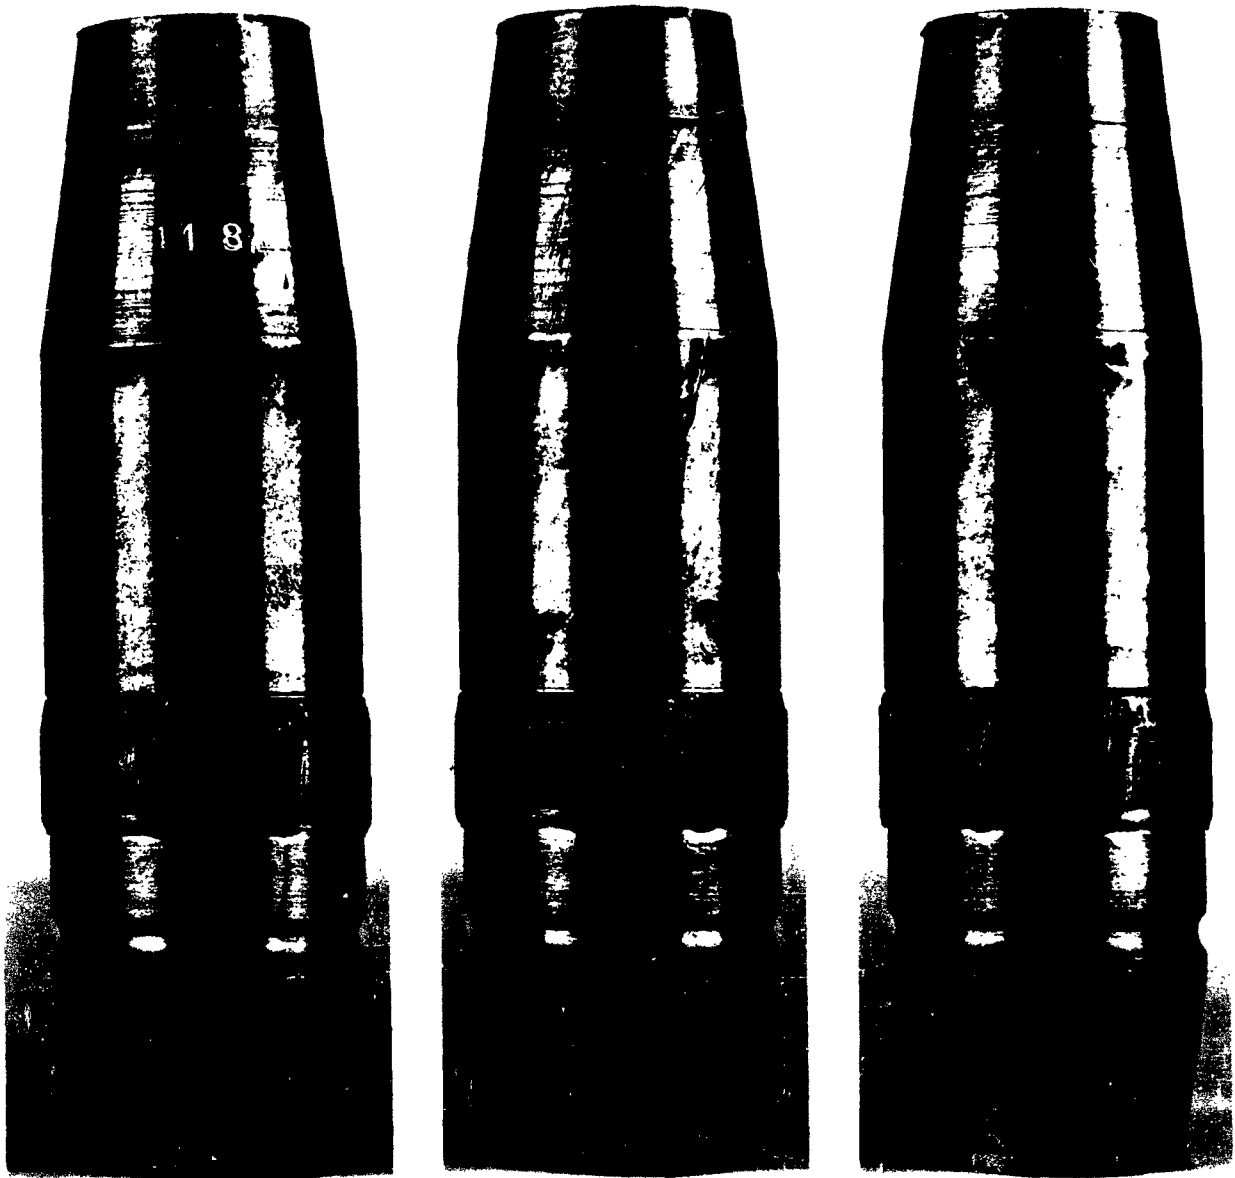
Figure 12

Three views (120° apart) of recovered 40mm T1E1 projectile (uncoated projectile, barrel initially coated for three round group). Projectile No. 1181.

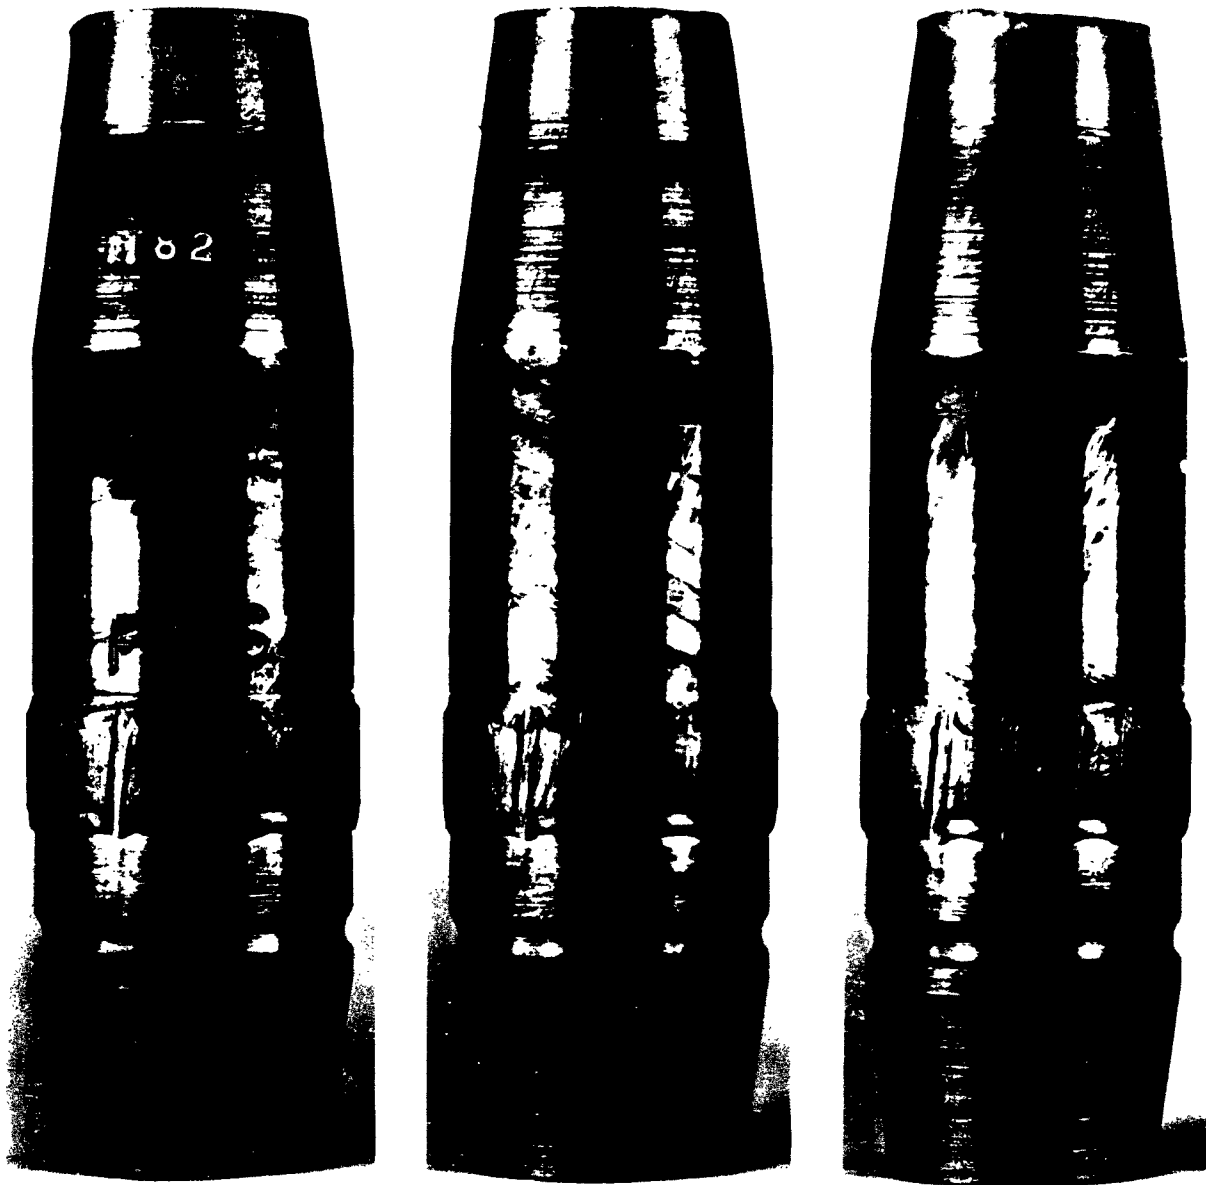
Figure 13

Three views (120° apart) of recovered 40mm T1E1 projectile (uncoated projectile, barrel initially coated for three round group). Projectile No. 1182.

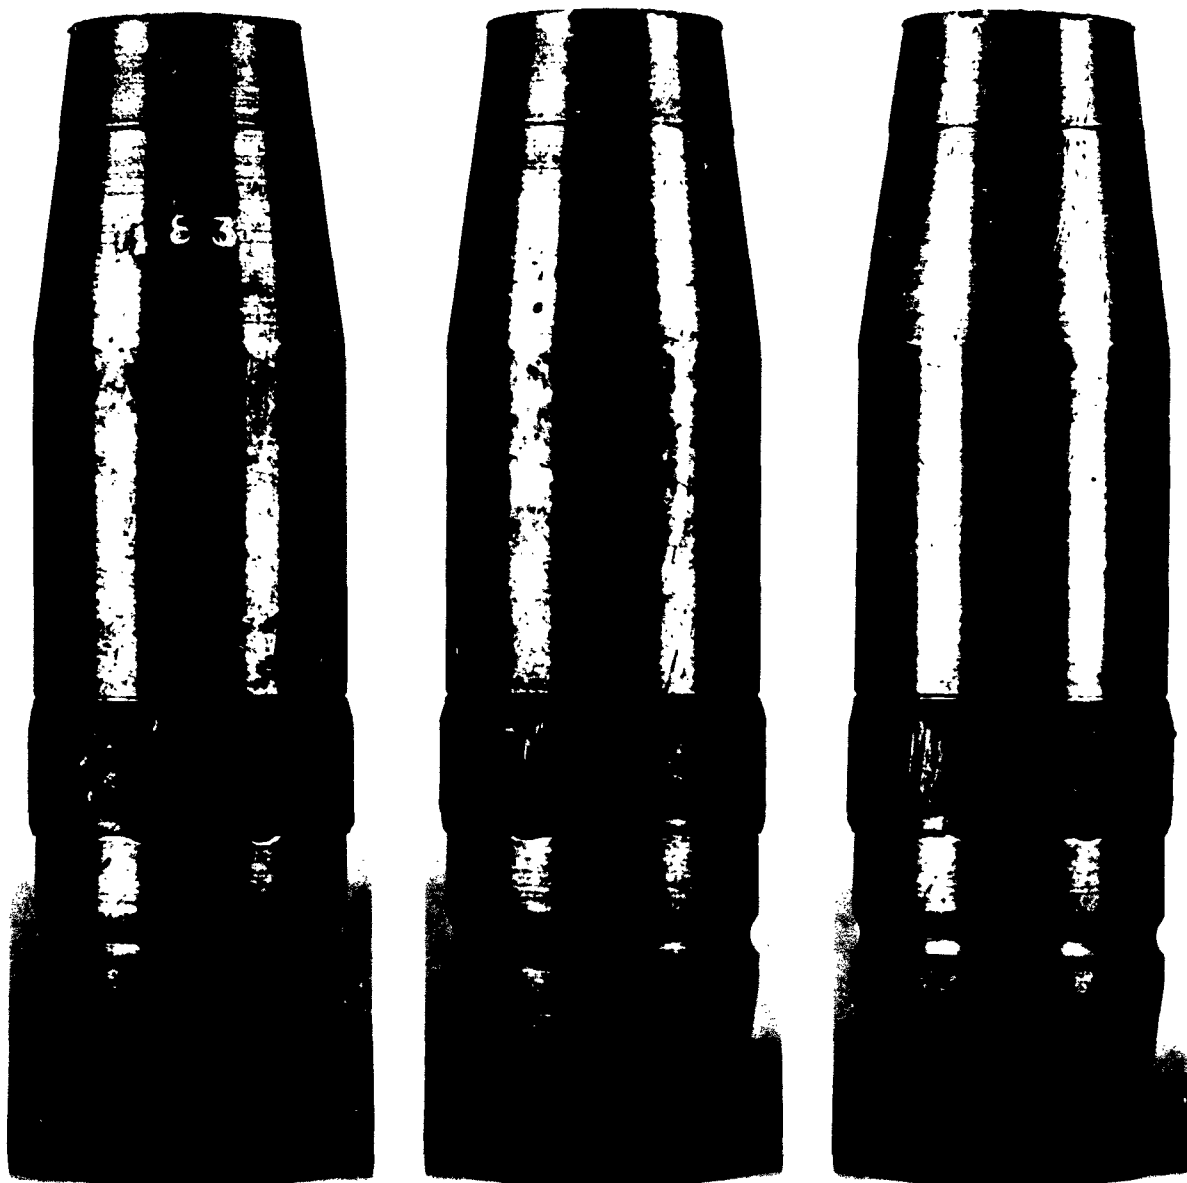
Figure 14

Three views (120° apart) of recovered 40mm T1E1 projectile (uncoated projectile, barrel initially coated for three round group). Projectile No. 1183.

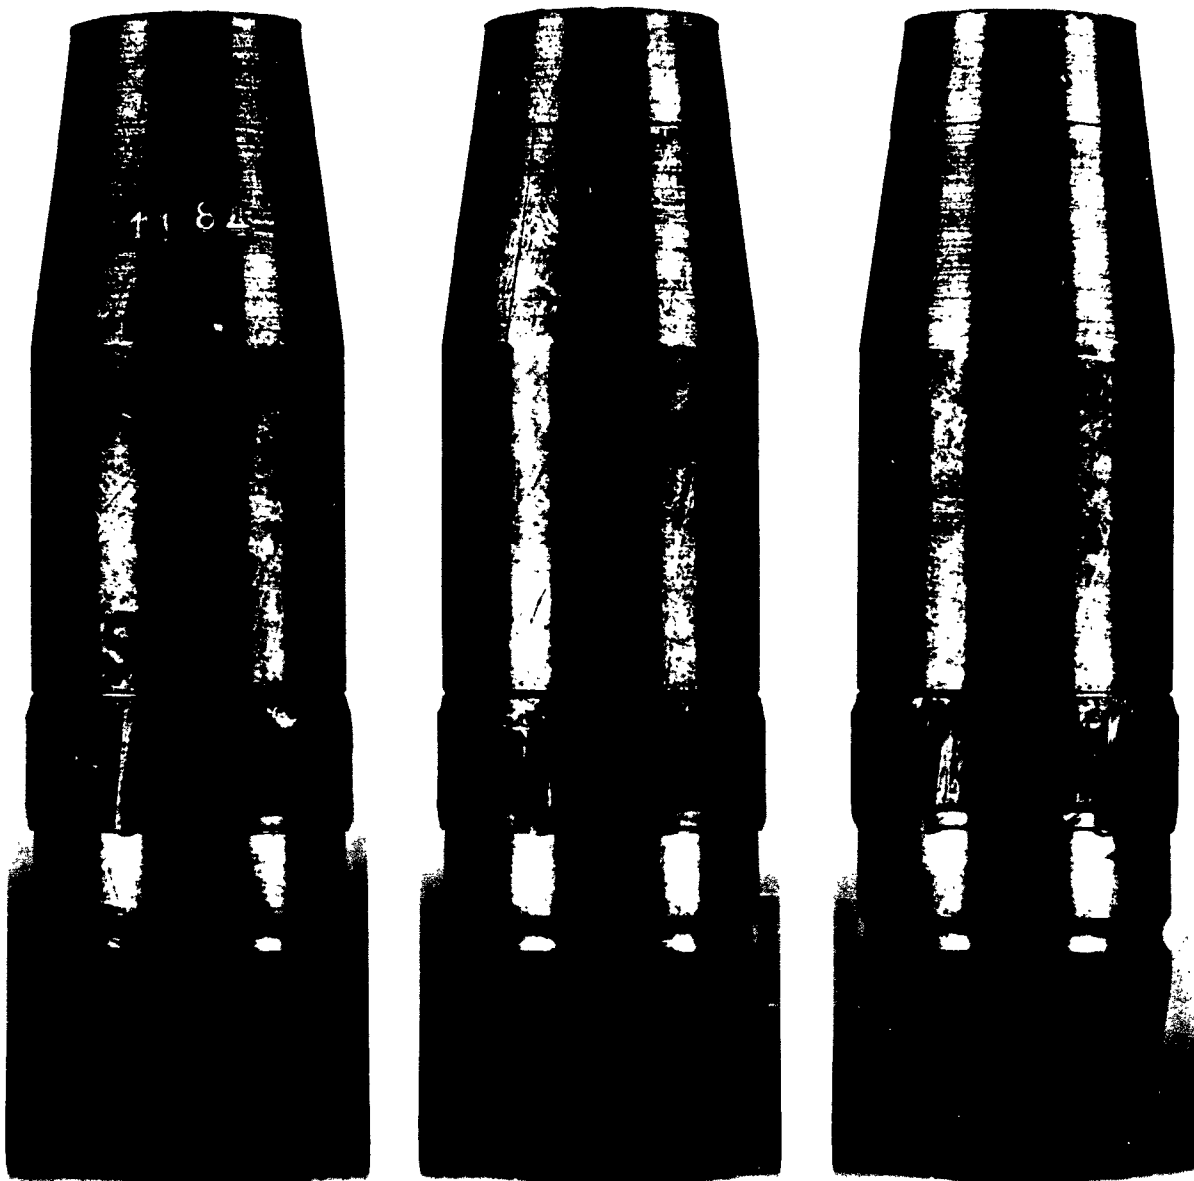
Figure 15

Three views (120° apart) of recovered 40mm T1E1 projectile (projectile completely coated, barrel initially coated for three round group). Projectile No. 1184.

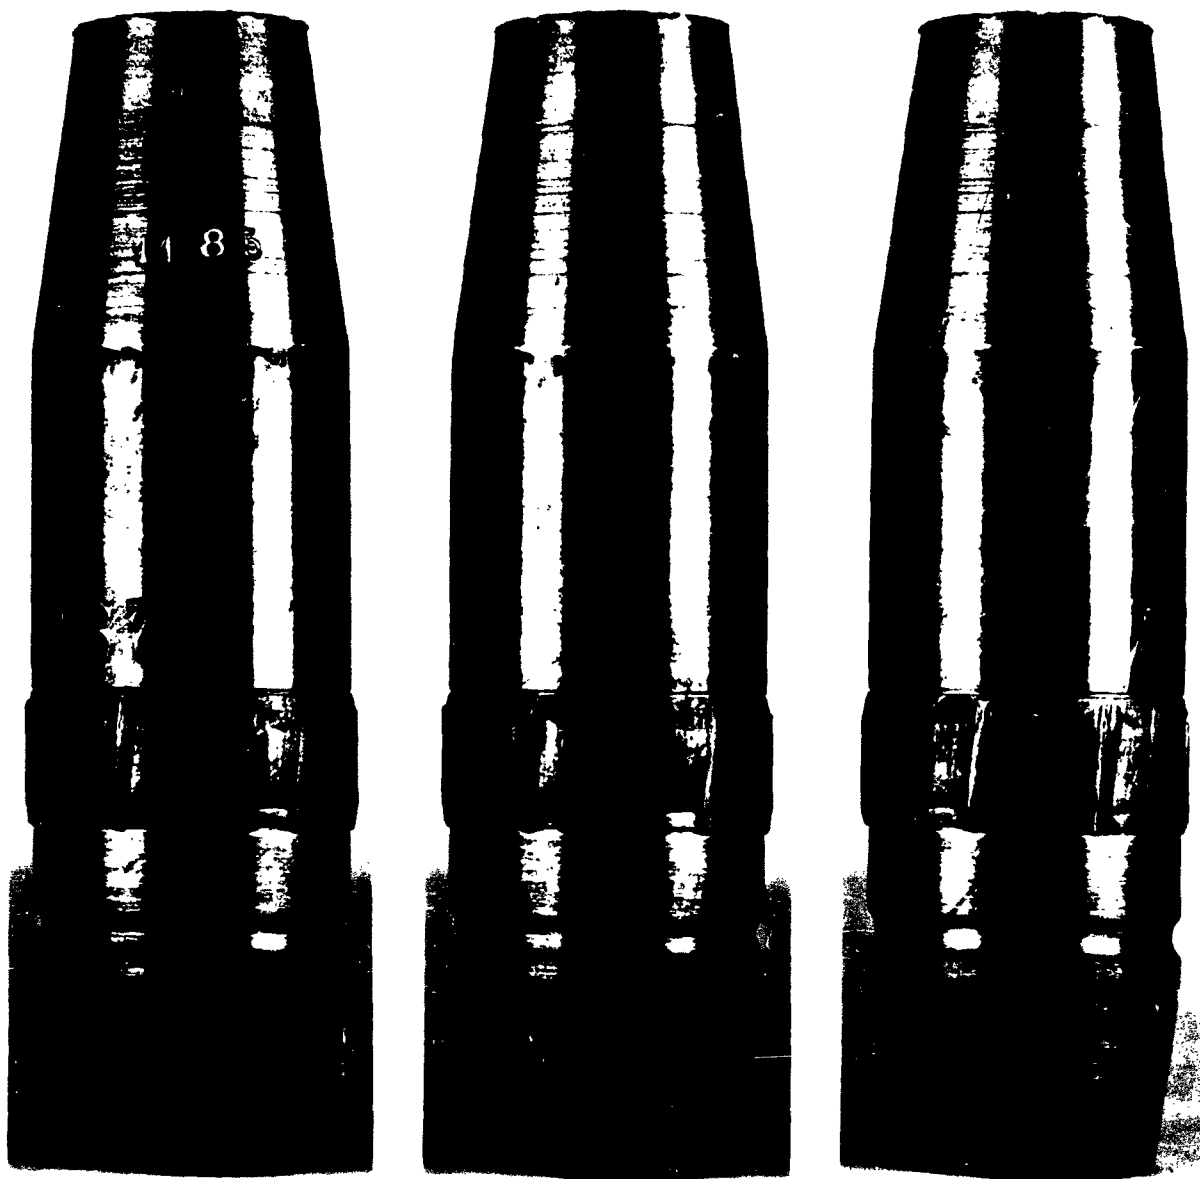
Figure 16

Three views (120° apart) of recovered 40mm T1E1 projectile (projectile completely coated, barrel initially coated for three round group). Projectile No. 1185.

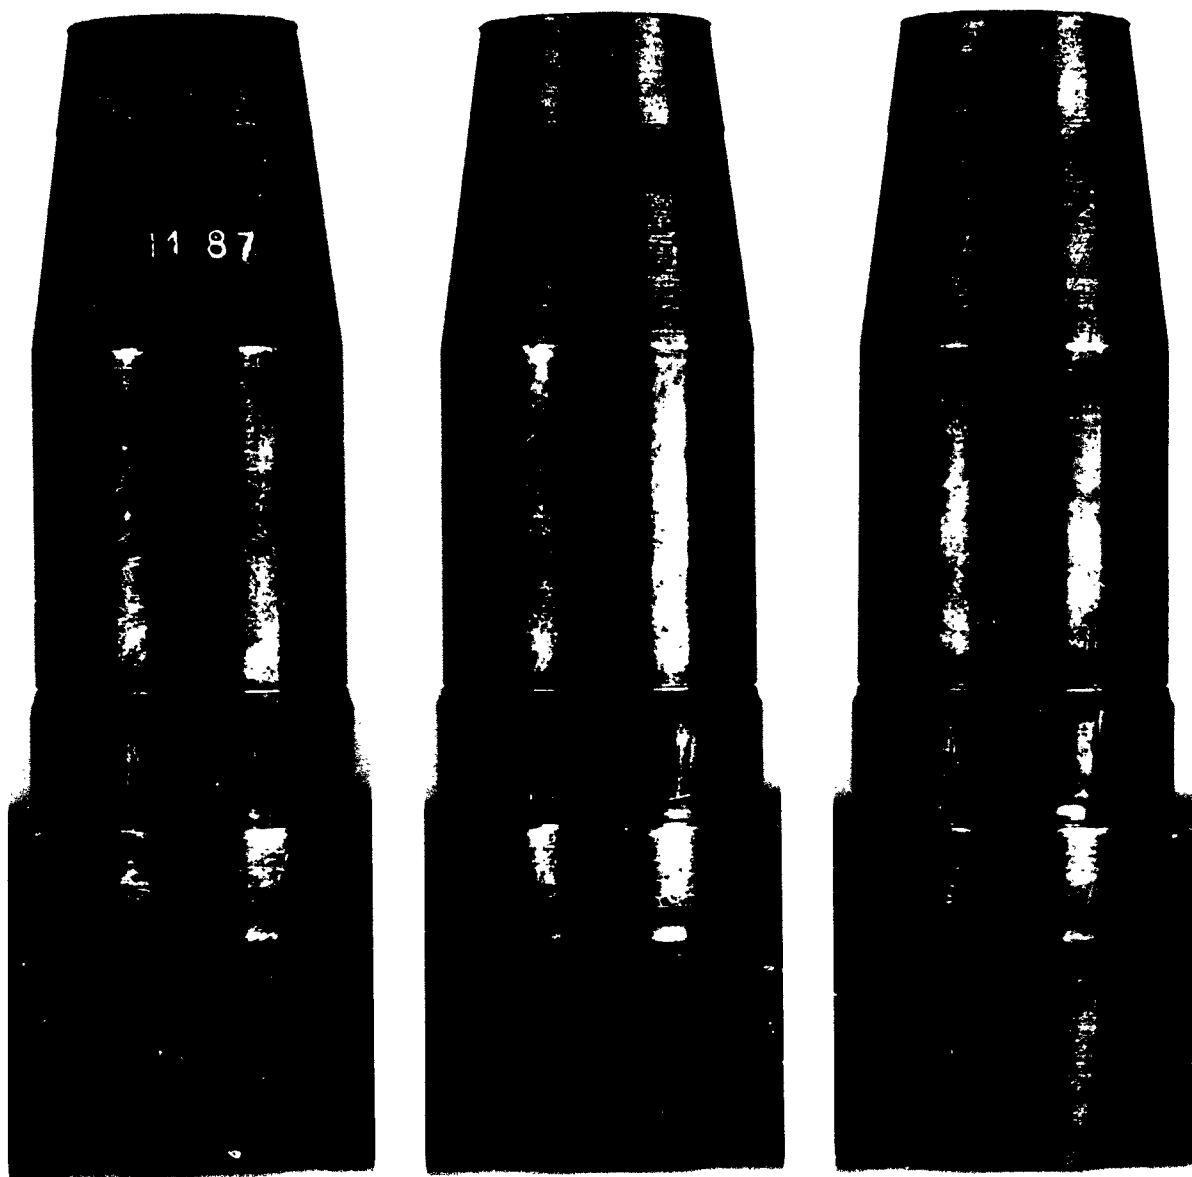
Figure 18

Three views (120° apart) of recovered 40mm T1E1 projectile
(projectile completely coated, barrel coated). Projectile
No. 1187.

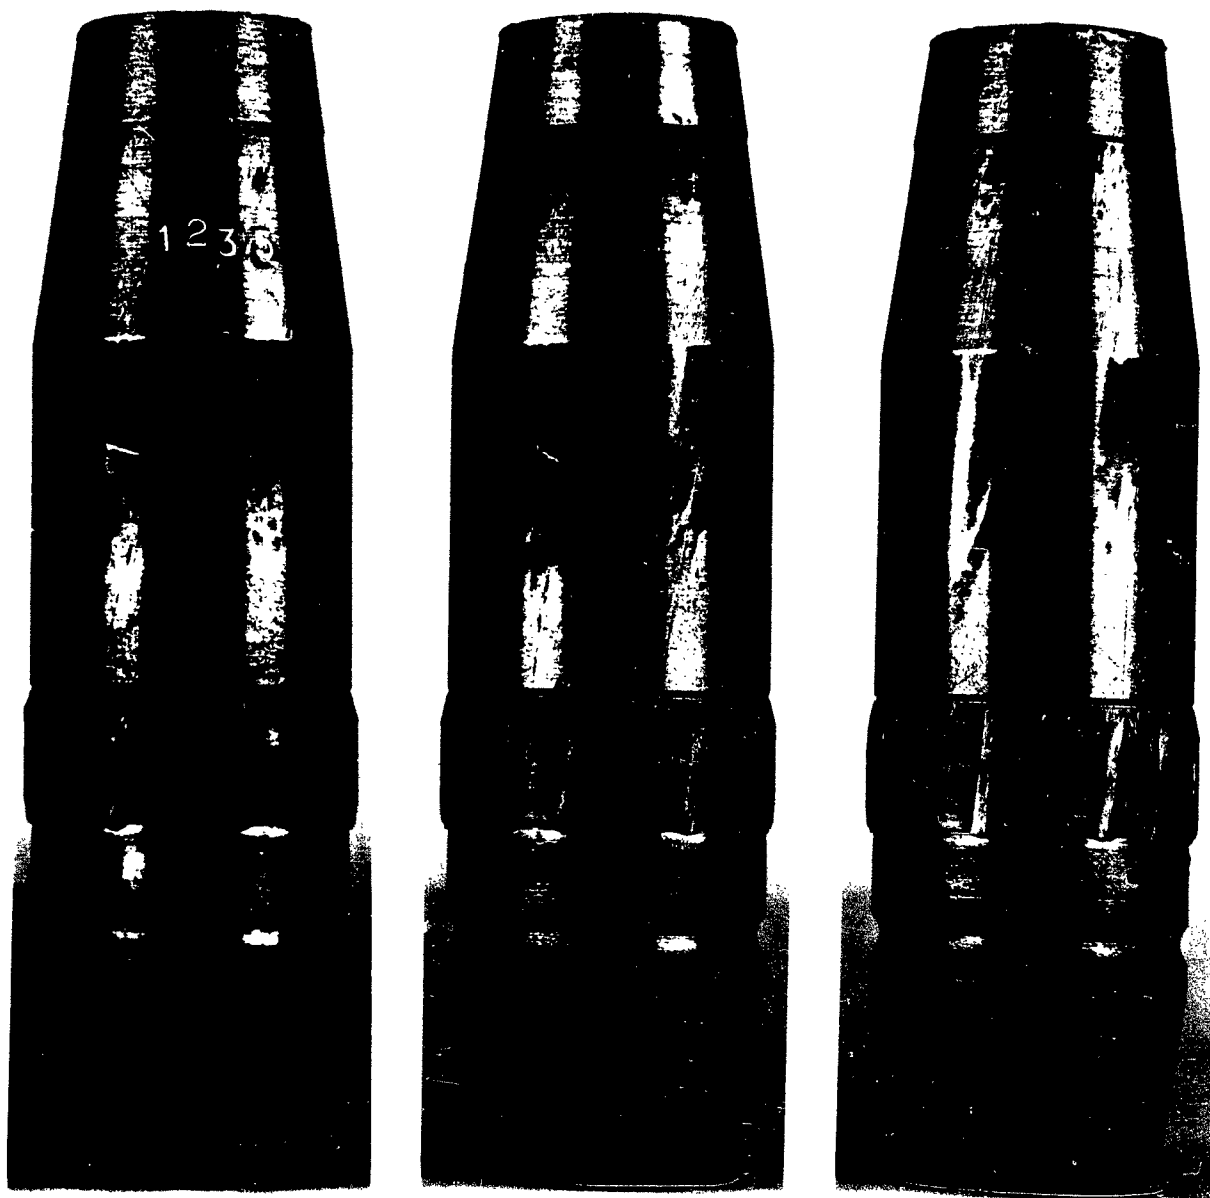
Figure 20

Three views (120° apart) of recovered 40mm T1E1 projectile (projectile completely coated, barrel coated). Projectile No. 1235.

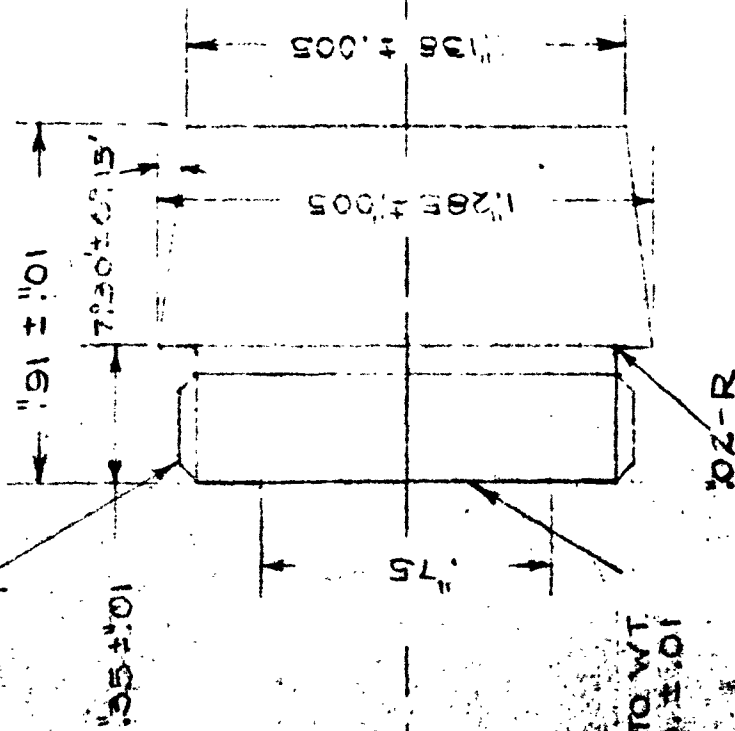
118-14 NS-2
 MAJOR DIA. 1.18 ± .0008
 PITCH DIA. 1.1356 ± .0036
 MINOR DIA. 1.0924 MAX.

1. DRILL TO WT
 2. WT 1.1518 ± .01

DUMMY NOSE PLUG
 FOR 40 MM PROJECTILE
 MAT'L: MEDIUM STEEL
 C1040 - C1137 OR SIMILAR
